# Extra Mile Inspections LLC

## General Information

**BUILDING ADDRESS:** 235 3rd Ave West  
**CITY:** Wendell  
**STATE / PROVINCE:** id  
**POSTAL CODE:** 83355  
**INSPECTION DESCRIPTION:** Buy/sell inspection  
**SQUARE FOOTAGE:** 2125  
**Picture:**

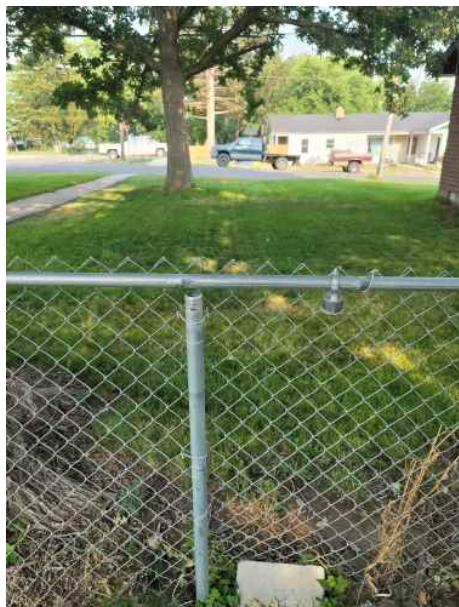
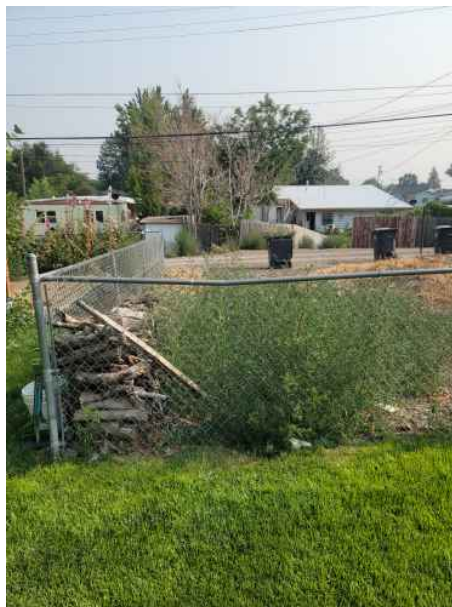
**FENCE** Fair

Chain link fence in fair condition except for a bent top rail and missing pole caps

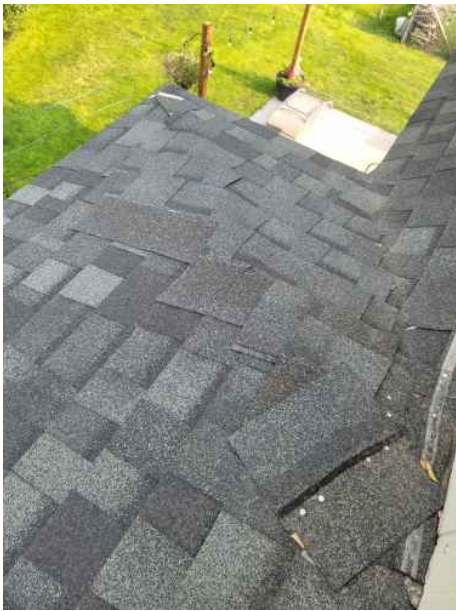
**SHINGLES MISSING / DAMAGED?** Satisfactory

Missing ridge cap on hip

Recommend further evaluation by a qualified roofer

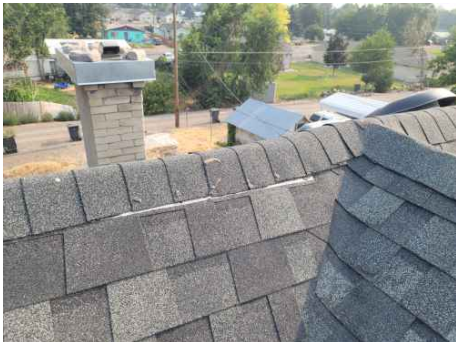
## **ROOF INSTALLATION** Fair

Exposed nail strip along ridge.

This is not necessarily cause for alarm, but something any homeowner should be aware of.

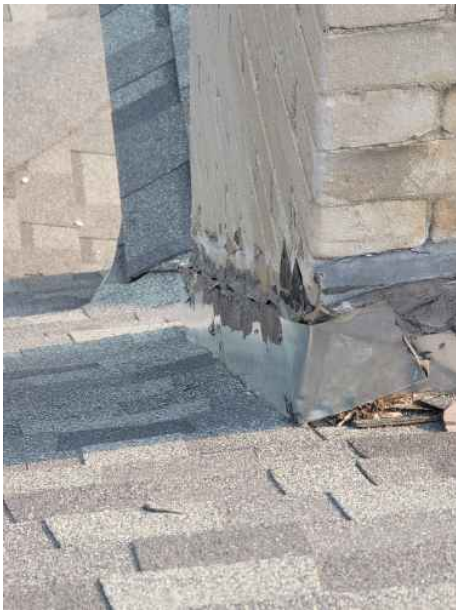
## **CHIMNEY** Poor

Flashing along chimney not sealed properly Recommend further evaluation by a qualified roofer

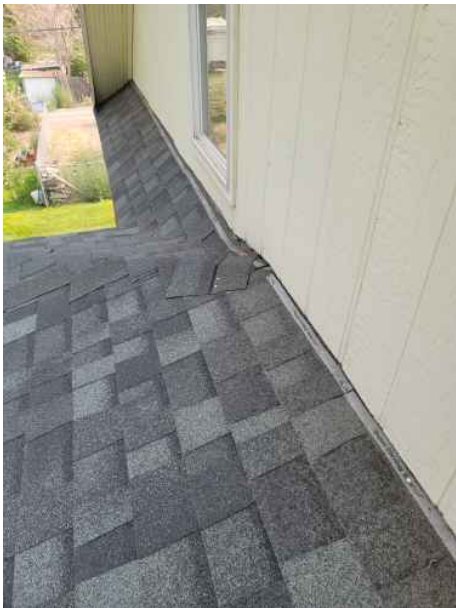
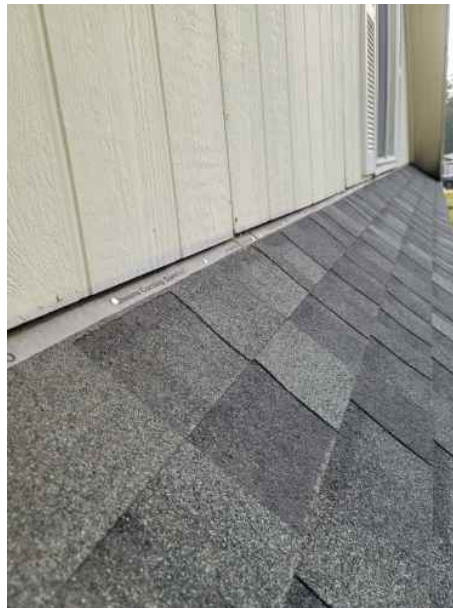
**FLASHING**    Poor

Missing proper flashing along siding at all headwalls  
Recommend further evaluation by qualified roofer

Missing proper flashing along siding at all headwalls

Recommend further evaluation by qualified roofer

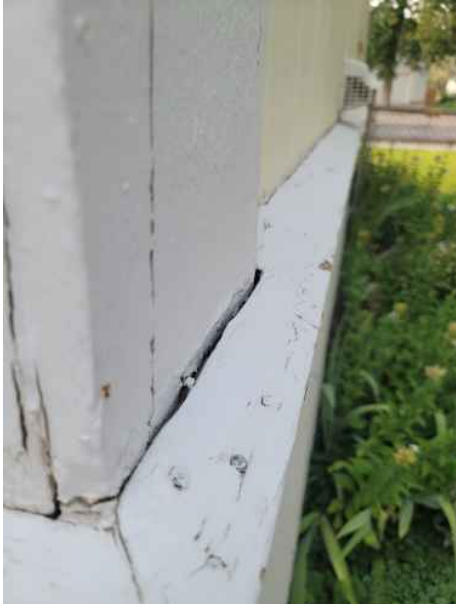
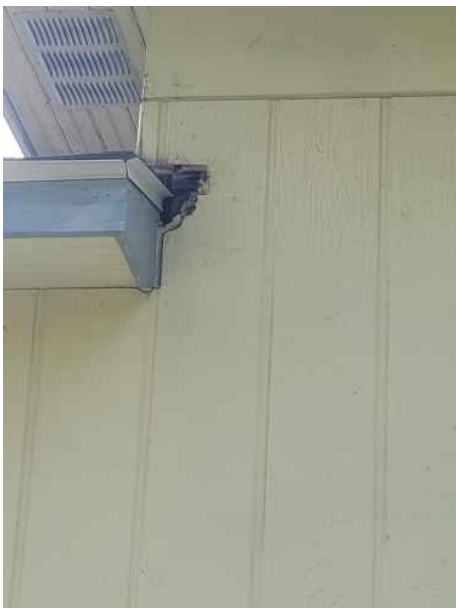
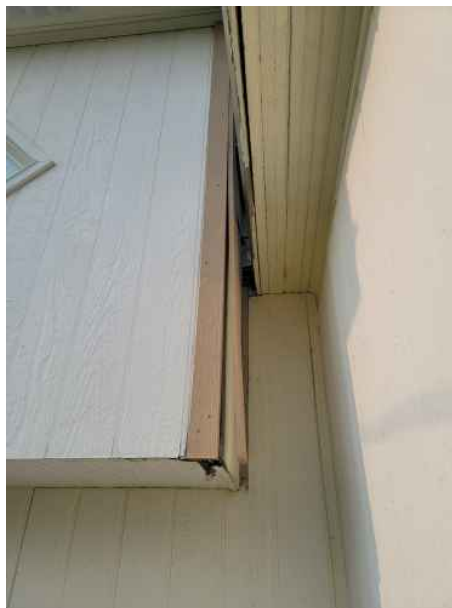
**SIDING CONDITION** Fair

Missing caulking along all belly ban trim

Missing siding along lower roof level

Recommend further evaluation by a qualified contractor.

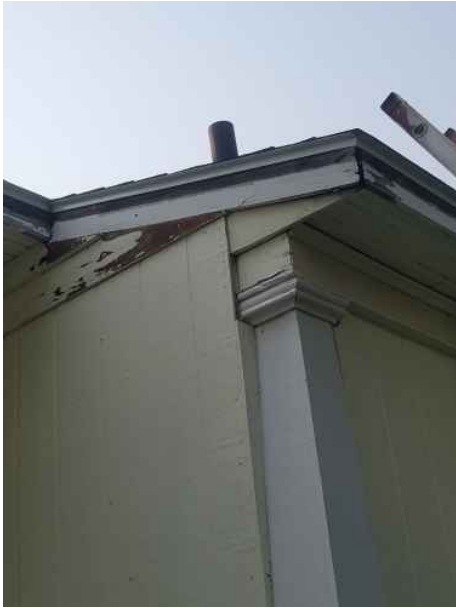
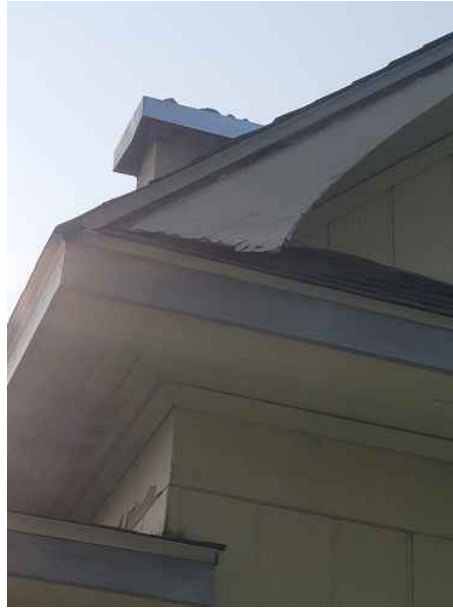
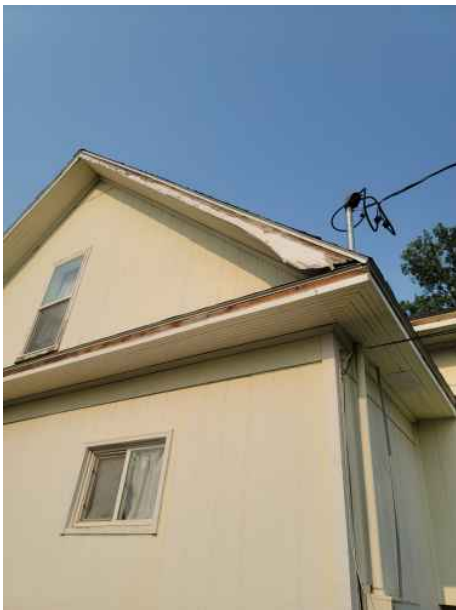
**FASCIA** Poor

Missing/peeling paint through entirety of fascia

Rotting and warped wood on all gable fascia

Recommend evaluation by qualified carpenter

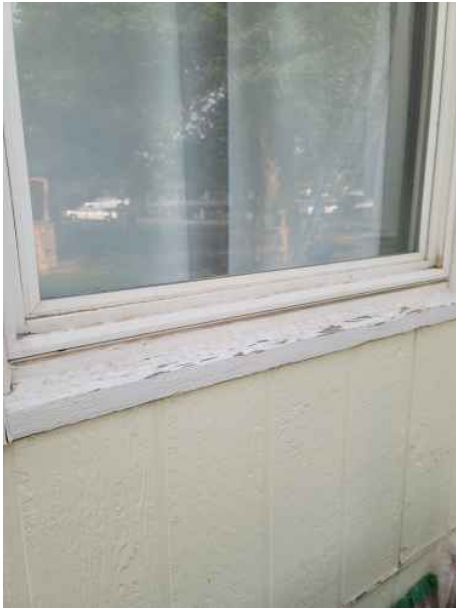
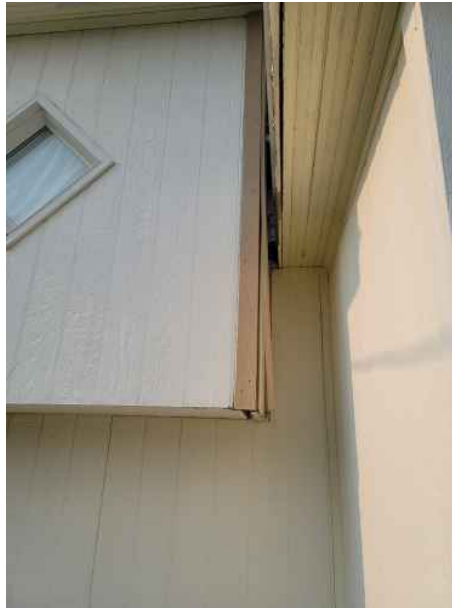
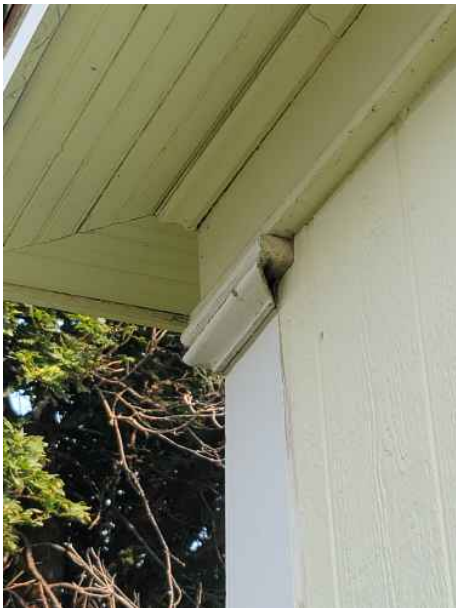
**TRIM** Fair

Peeling paint throughout

Warped corner trim

Missing trim

Recommend further evaluation by qualified carpenter/Painter

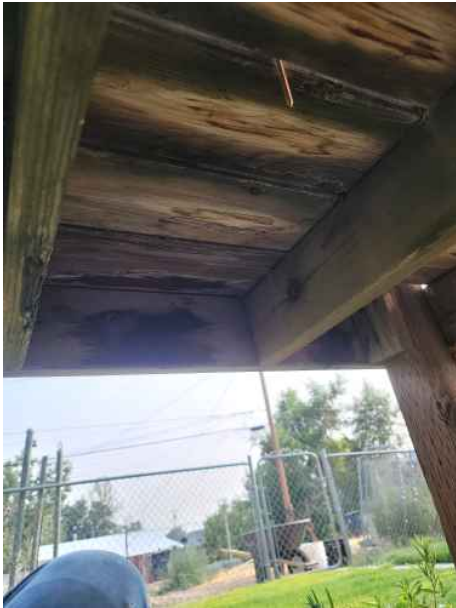
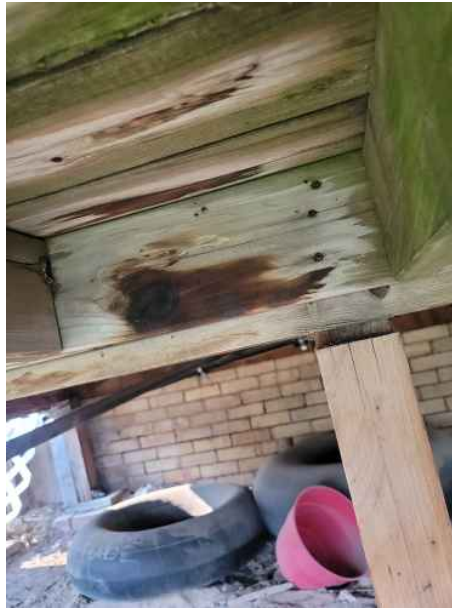
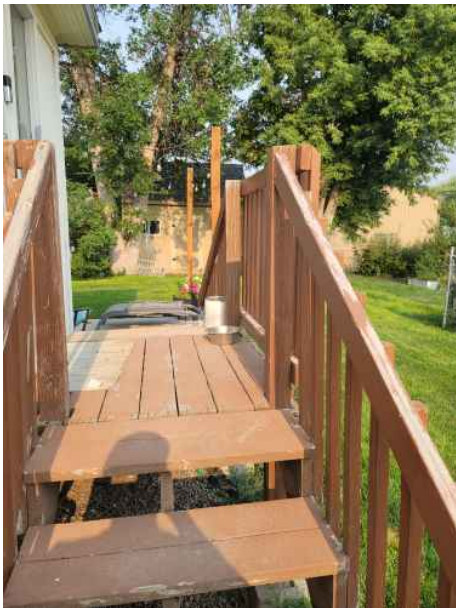
**DECKS** Poor

Improper anchoring to rim joist

Missing joist hangers

Peeling stain

**Improper anchoring to rim joist**

**Missing joist hangers**

**Peeling stain**

Recommend further evaluation by qualified carpenter

**Recommend further evaluation by qualified carpenter**

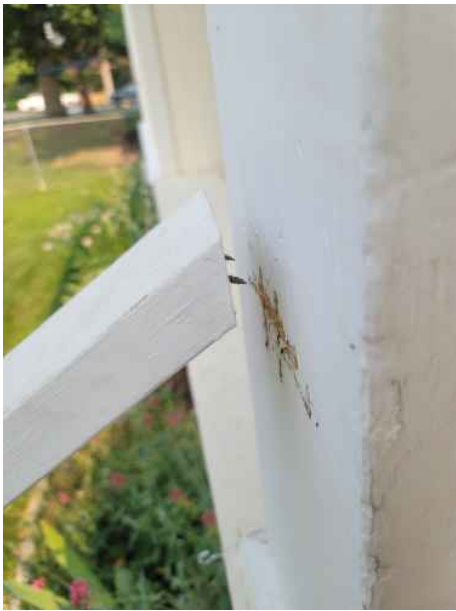
## **STOOP / PORCH** Fair

Loose handrail

**Loose handrail**

Recommend evaluation by qualified carpenter

**Recommend evaluation by qualified carpenter**

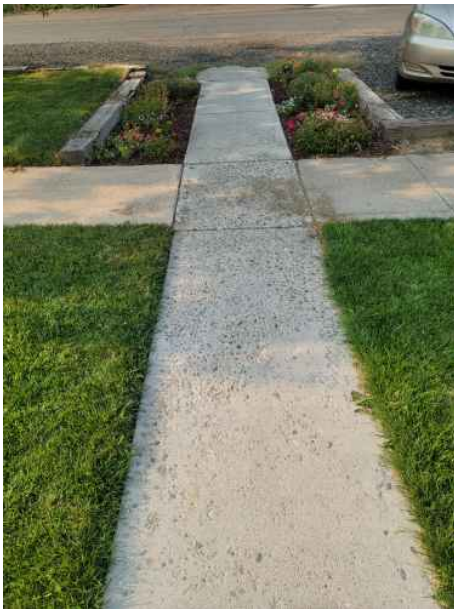
**WALKWAYS** Fair

Spalding present

This is not necessarily cause for alarm, but something any homeowner should be aware of.

**Spalding present**

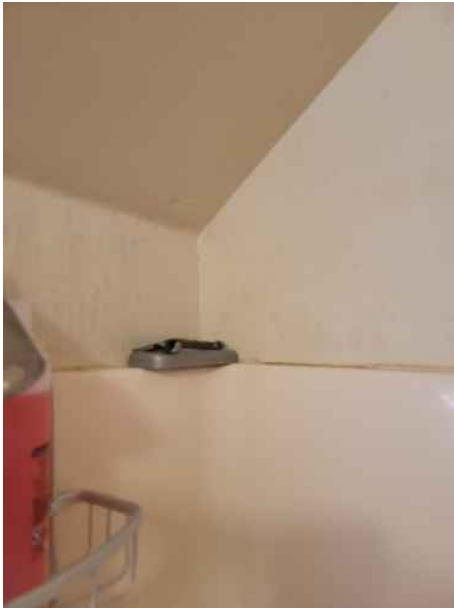
**WALLS** Fair

Mildew and peeling paint present around bath surround Recommend further evaluation by a qualified contractor.

**Mildew and peeling paint present around bath surround Recommend further evaluation by a qualified contractor.**

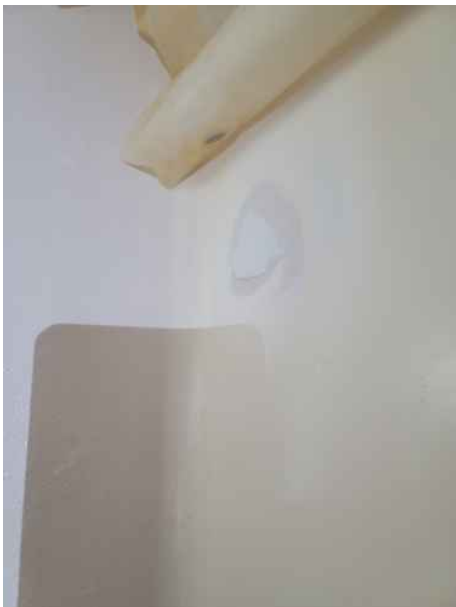
**BATHTUB / SHOWER** Fair

Noticeable patch does not seem to be actively leaking

**Noticeable patch does not seem to be actively leaking**

Continue to monitor, if condition deteriorates contact a qualified contractor.

**Continue to monitor, if condition deteriorates contact a qualified contractor.**

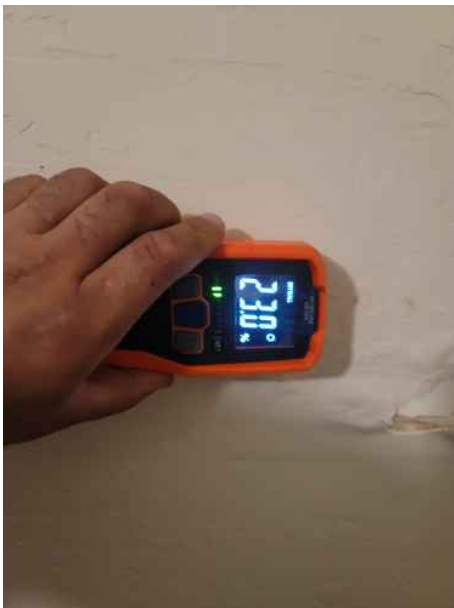
**WALLS** Poor

Minor water damage south wall  
Recommend evaluation from qualified restoration tech

**Minor water damage south wall**

**Recommend evaluation from qualified restoration tech**

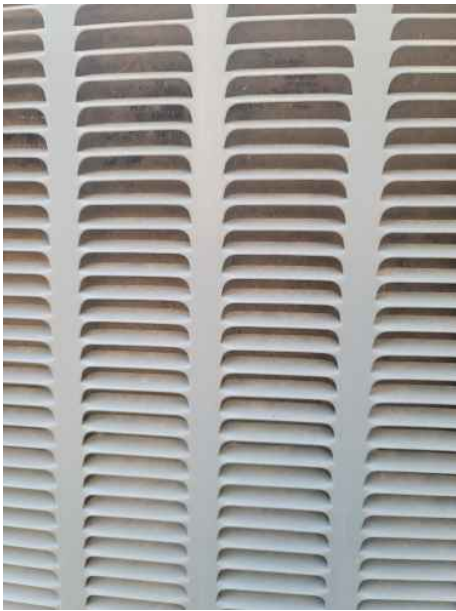
**COOLING SYSTEM**     Fair

Fins covered in dust and debris

recommend evaluation by licensed HVAC tech
